TNR153856 - Norfolk Southern Intermodal Facility Photos

Permit No.:	Site Location:	Permittee:	Date:	Time On-Site
TNR153856	3000 Norfolk Southern Way, Rossville, Fayette Co., TN	Norfolk Southern Railway	May 26, 2017	12:00 PM

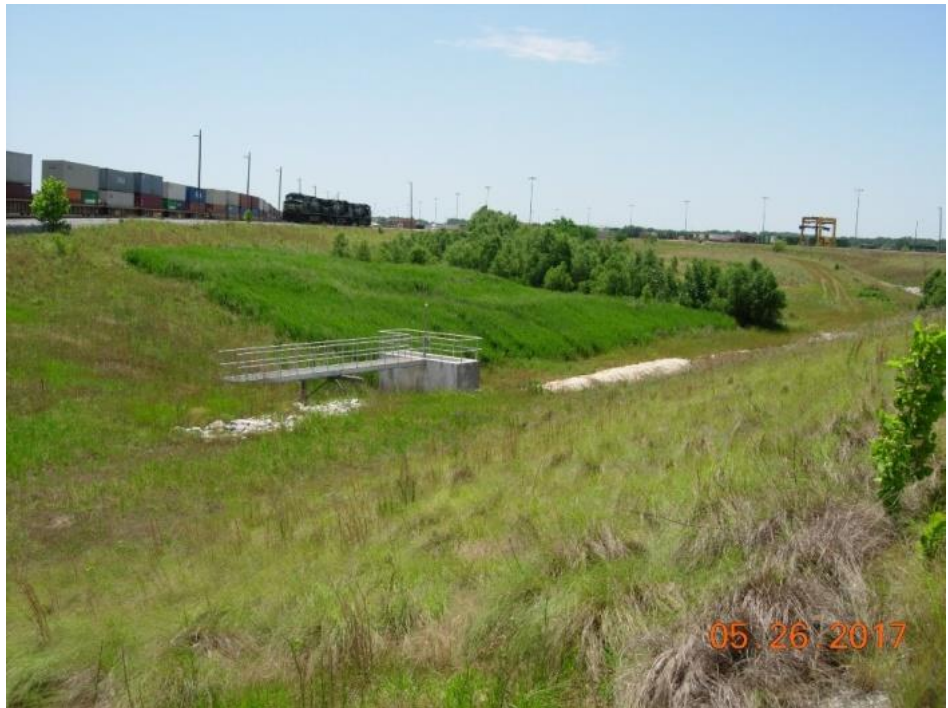
3	Cliff Caudle			
Description Additional view from the north end of Permanent Basin 4 - view south showing re-grading and effective revegetation of basin slopes up-gradient of the slotted outfall structure (arrow). (Compare photo 4 – Aug. 18, 2016 inspection)				
Photo No.	Photographer

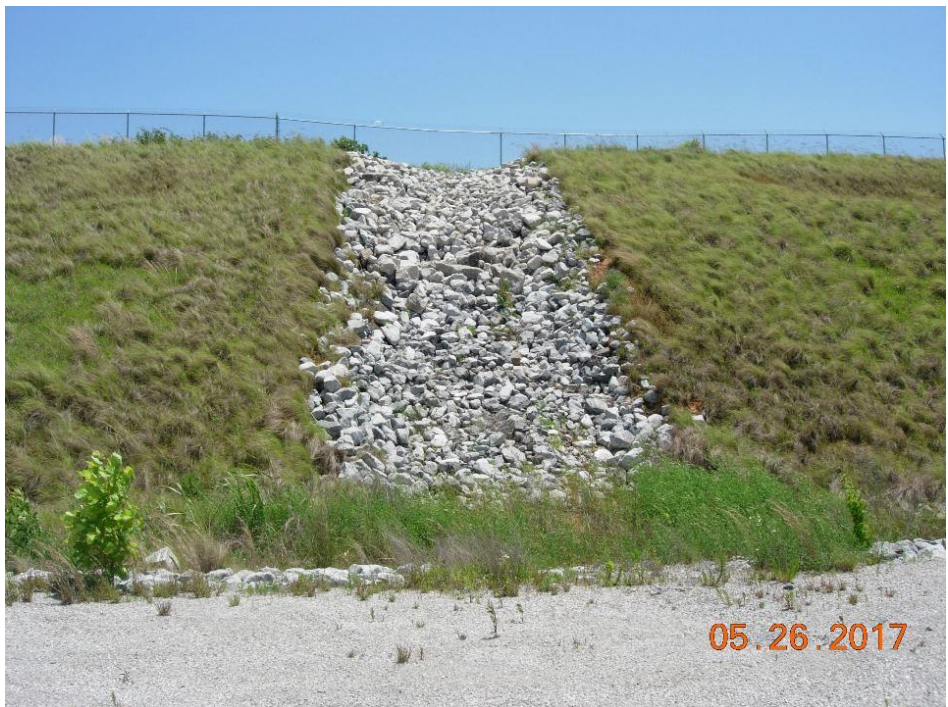
4	Cliff Caudle			
Description View east showing the rip-rap flume down the large eastern slope that had previously failed near light pole 115. Additional work had been performed here since the August 18, 2016 inspection. The flume appeared to be well-stabilized. (Compare photo 5 – Aug. 18, 2016 inspection)

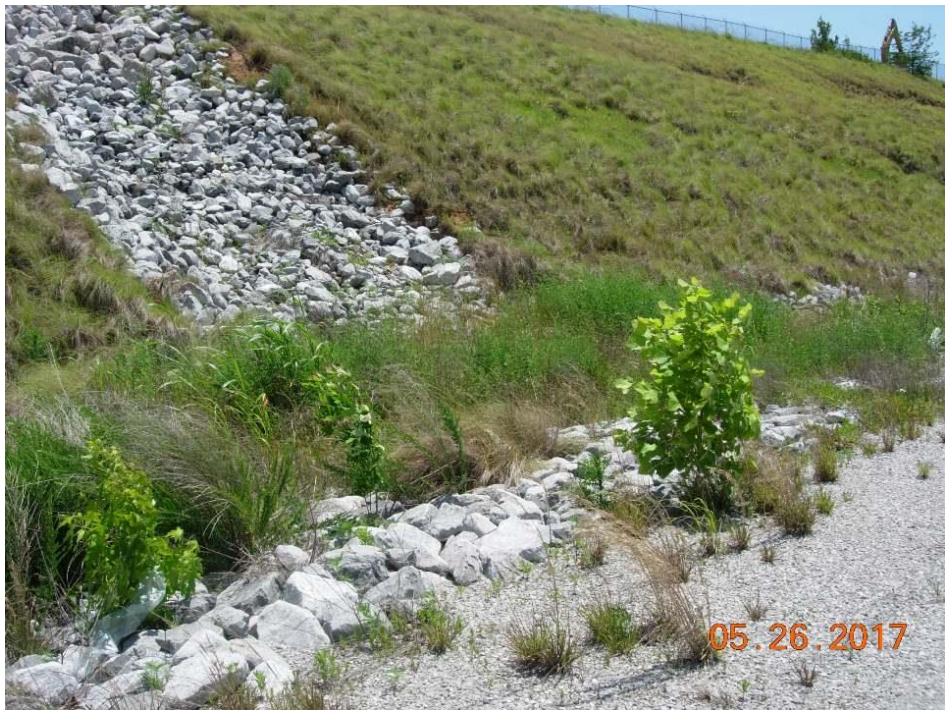
5	Cliff Caudle			
Description				
View southeast showing the area where sediment accumulation had previously occurred below the rip-rap flume shown in photo 4. The area appeared well-vegetated. <i>(Compare photo 6 – Aug. 18, 2016 inspection)</i>				
Photo No.	Photographer

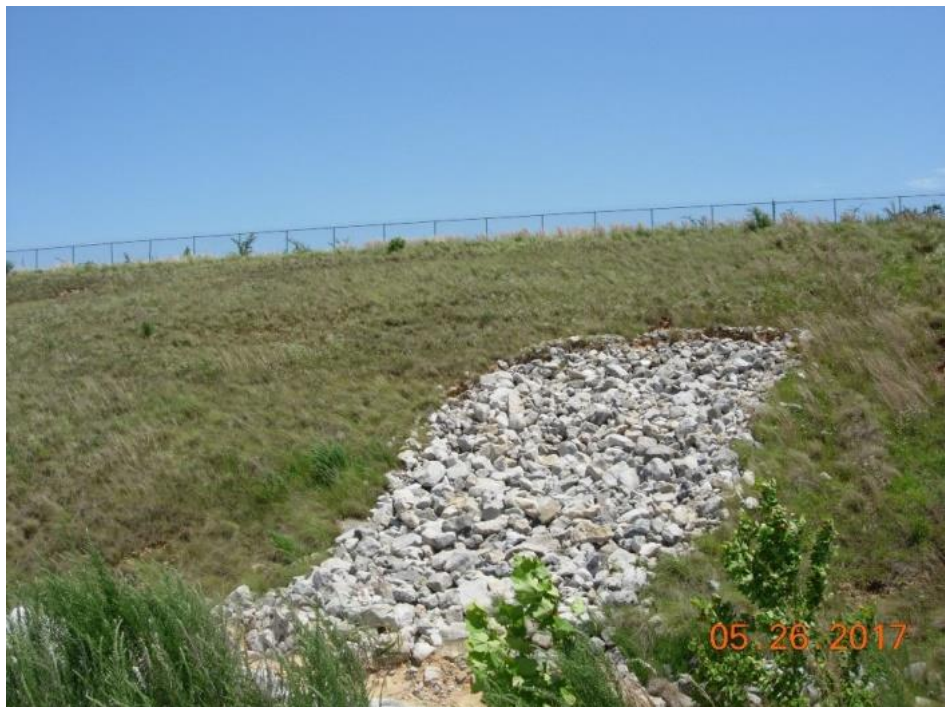
6	Cliff Caudle			
Description				
View east showing the previous slump slope failure that had occurred near light pole 125. The slump had been repaired with rip-rap and the sediment that had previously accumulated below the slump had been removed to restore channel flow at the toe of the slope. The restored flow line at the toe of the slope has a mostly sandy bottom. No issues observed. <i>(Compare photo 7 – Aug. 18, 2016 inspection)</i>

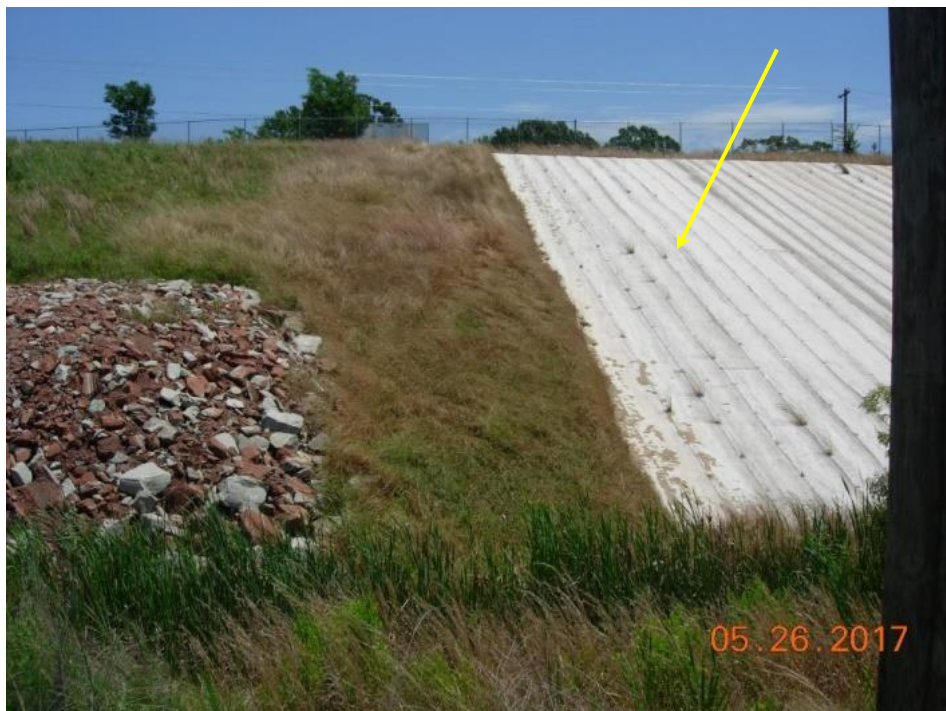
7	Cliff Caudle			
Description				
View eastward showing the north end of the former large, sparsely vegetated area in the vicinity of light pole 129 above the eastern conveyance, as noted in both the May 6, 2016 and August 18, 2016 inspections. The slope had been fully stabilized with a geosynthetic cementitious composite matting (arrow), which appeared to have been correctly keyed into grade on all sides. The slope appeared to be fully stabilized. (Compare photo 8 – Aug. 18, 2016 inspection)				
Photo No.	Photographer

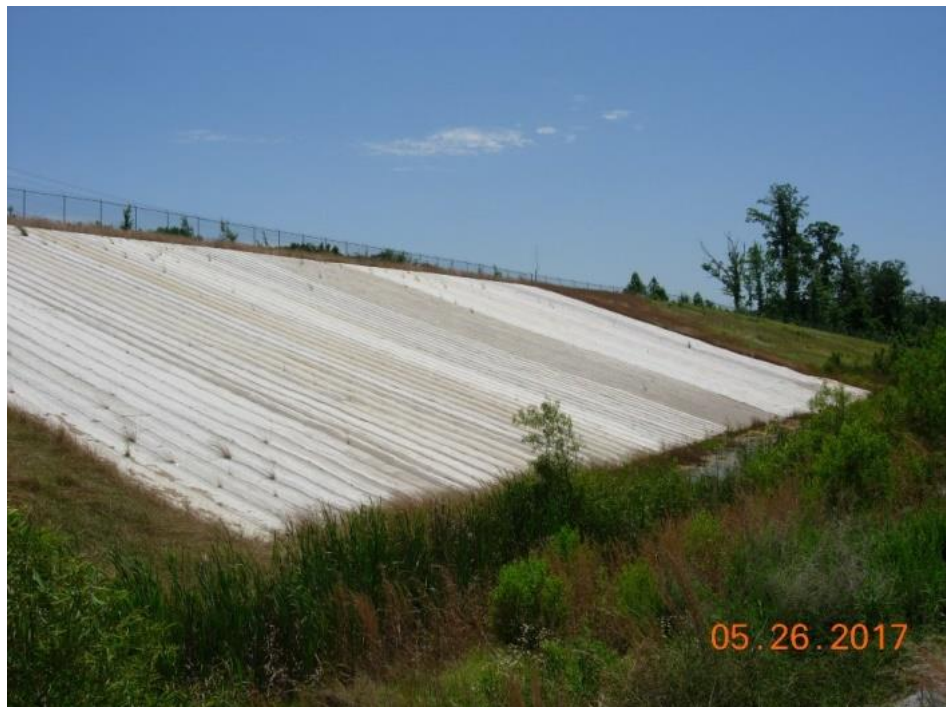
8	Cliff Caudle			
Description				
View southeastward showing the former large, sparsely vegetated area in the vicinity of light pole 129 above the eastern conveyance, as noted in both the May 6, 2016 and August 18, 2016 inspections. The slope had been fully stabilized with a geosynthetic cementitious composite matting (arrow), which appeared to have been correctly keyed into grade on all sides. The slope appeared to be fully stabilized. (Compare photo 8 – Aug. 18, 2016 inspection)

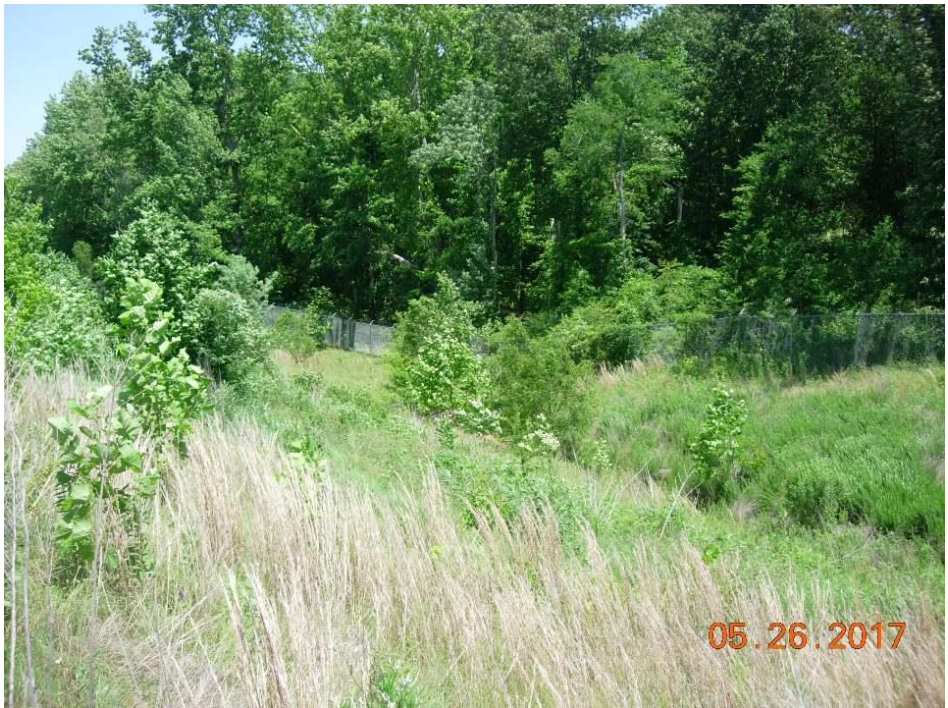
9	Cliff Caudle			
Description	The area around Outfall SW9 (the discharge point to Stream 5) appeared well vegetated. (Compare photo 11 – Aug. 18, 2016 inspection)			
Photo No.	Photographer

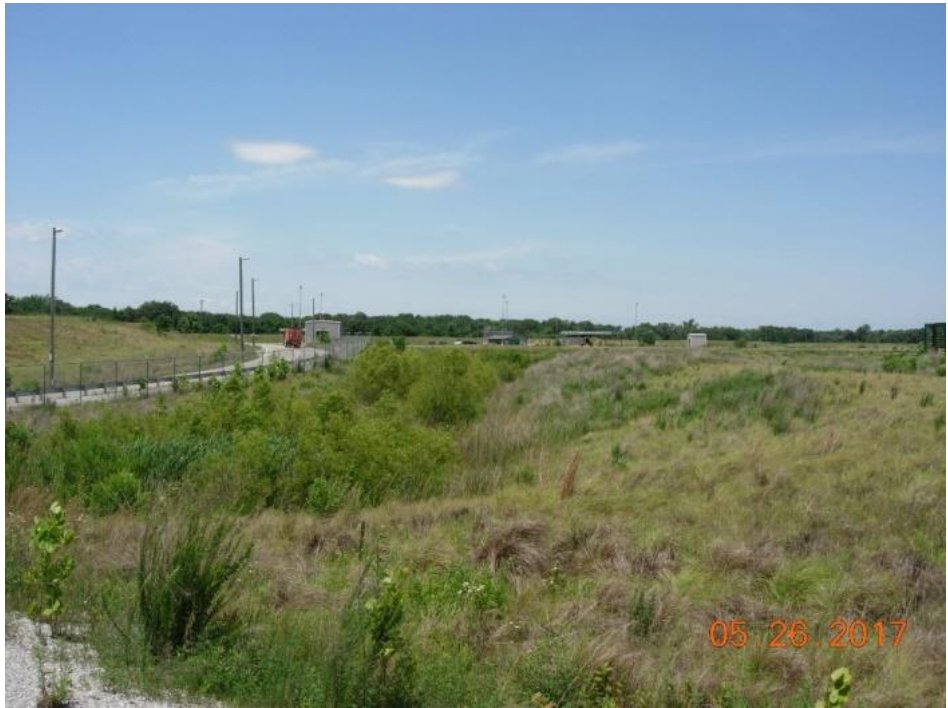
10	Cliff Caudle			
Description	View northwest from the south end of Permanent Basin 3, which appeared well-vegetated. (Compare photo 12 – Aug. 18, 2016 inspection)
